National Energy
Board

Investigation under the *National Energy Board Act*

**30 September 2009 release of gas and
subsequent fire at the Enbridge Gas
Distribution Inc. Lisgar Gate Station in
Mississauga, Ontario**

November 2012

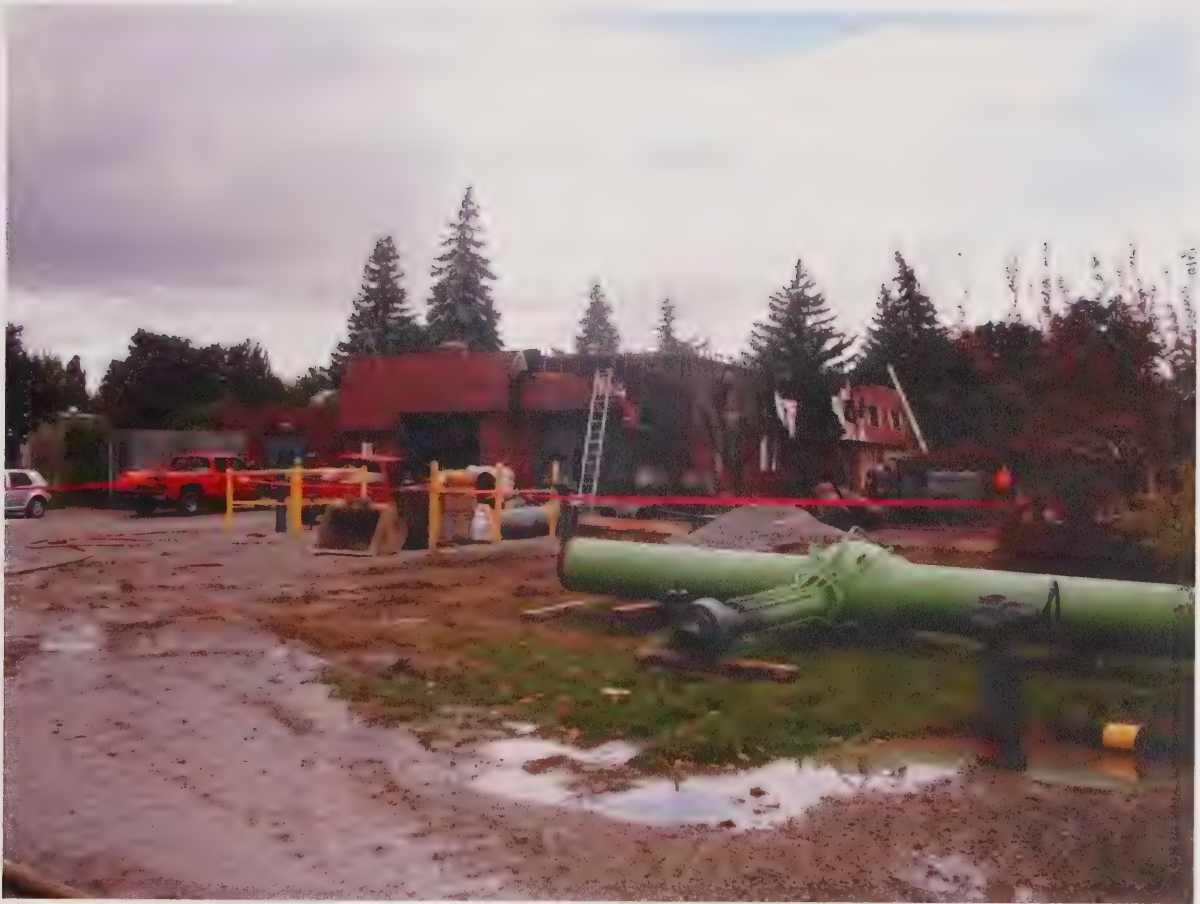
Figure 1. Lisgar Gate Station

The Lisgar Station shown in Figure 1 is located in Mississauga, Ontario, south of Highway 401 on Winston Churchill Boulevard at Aquataine Avenue (Appendix I).
